AMMRC TR 84-39

# MOBILE ACCELERATOR NEUTRON RADIOGRAPHY SYSTEM

W. E. DANCE, S. F. CAROLLO, AND H. M. BUMGARDNER  
LTV AEROSPACE AND DEFENSE COMPANY  
VOUGHT MISSILES AND ADVANCED PROGRAMS DIVISION  
P. O. BOX 650003  
DALLAS, TEXAS 75265-0003

FINAL REPORT

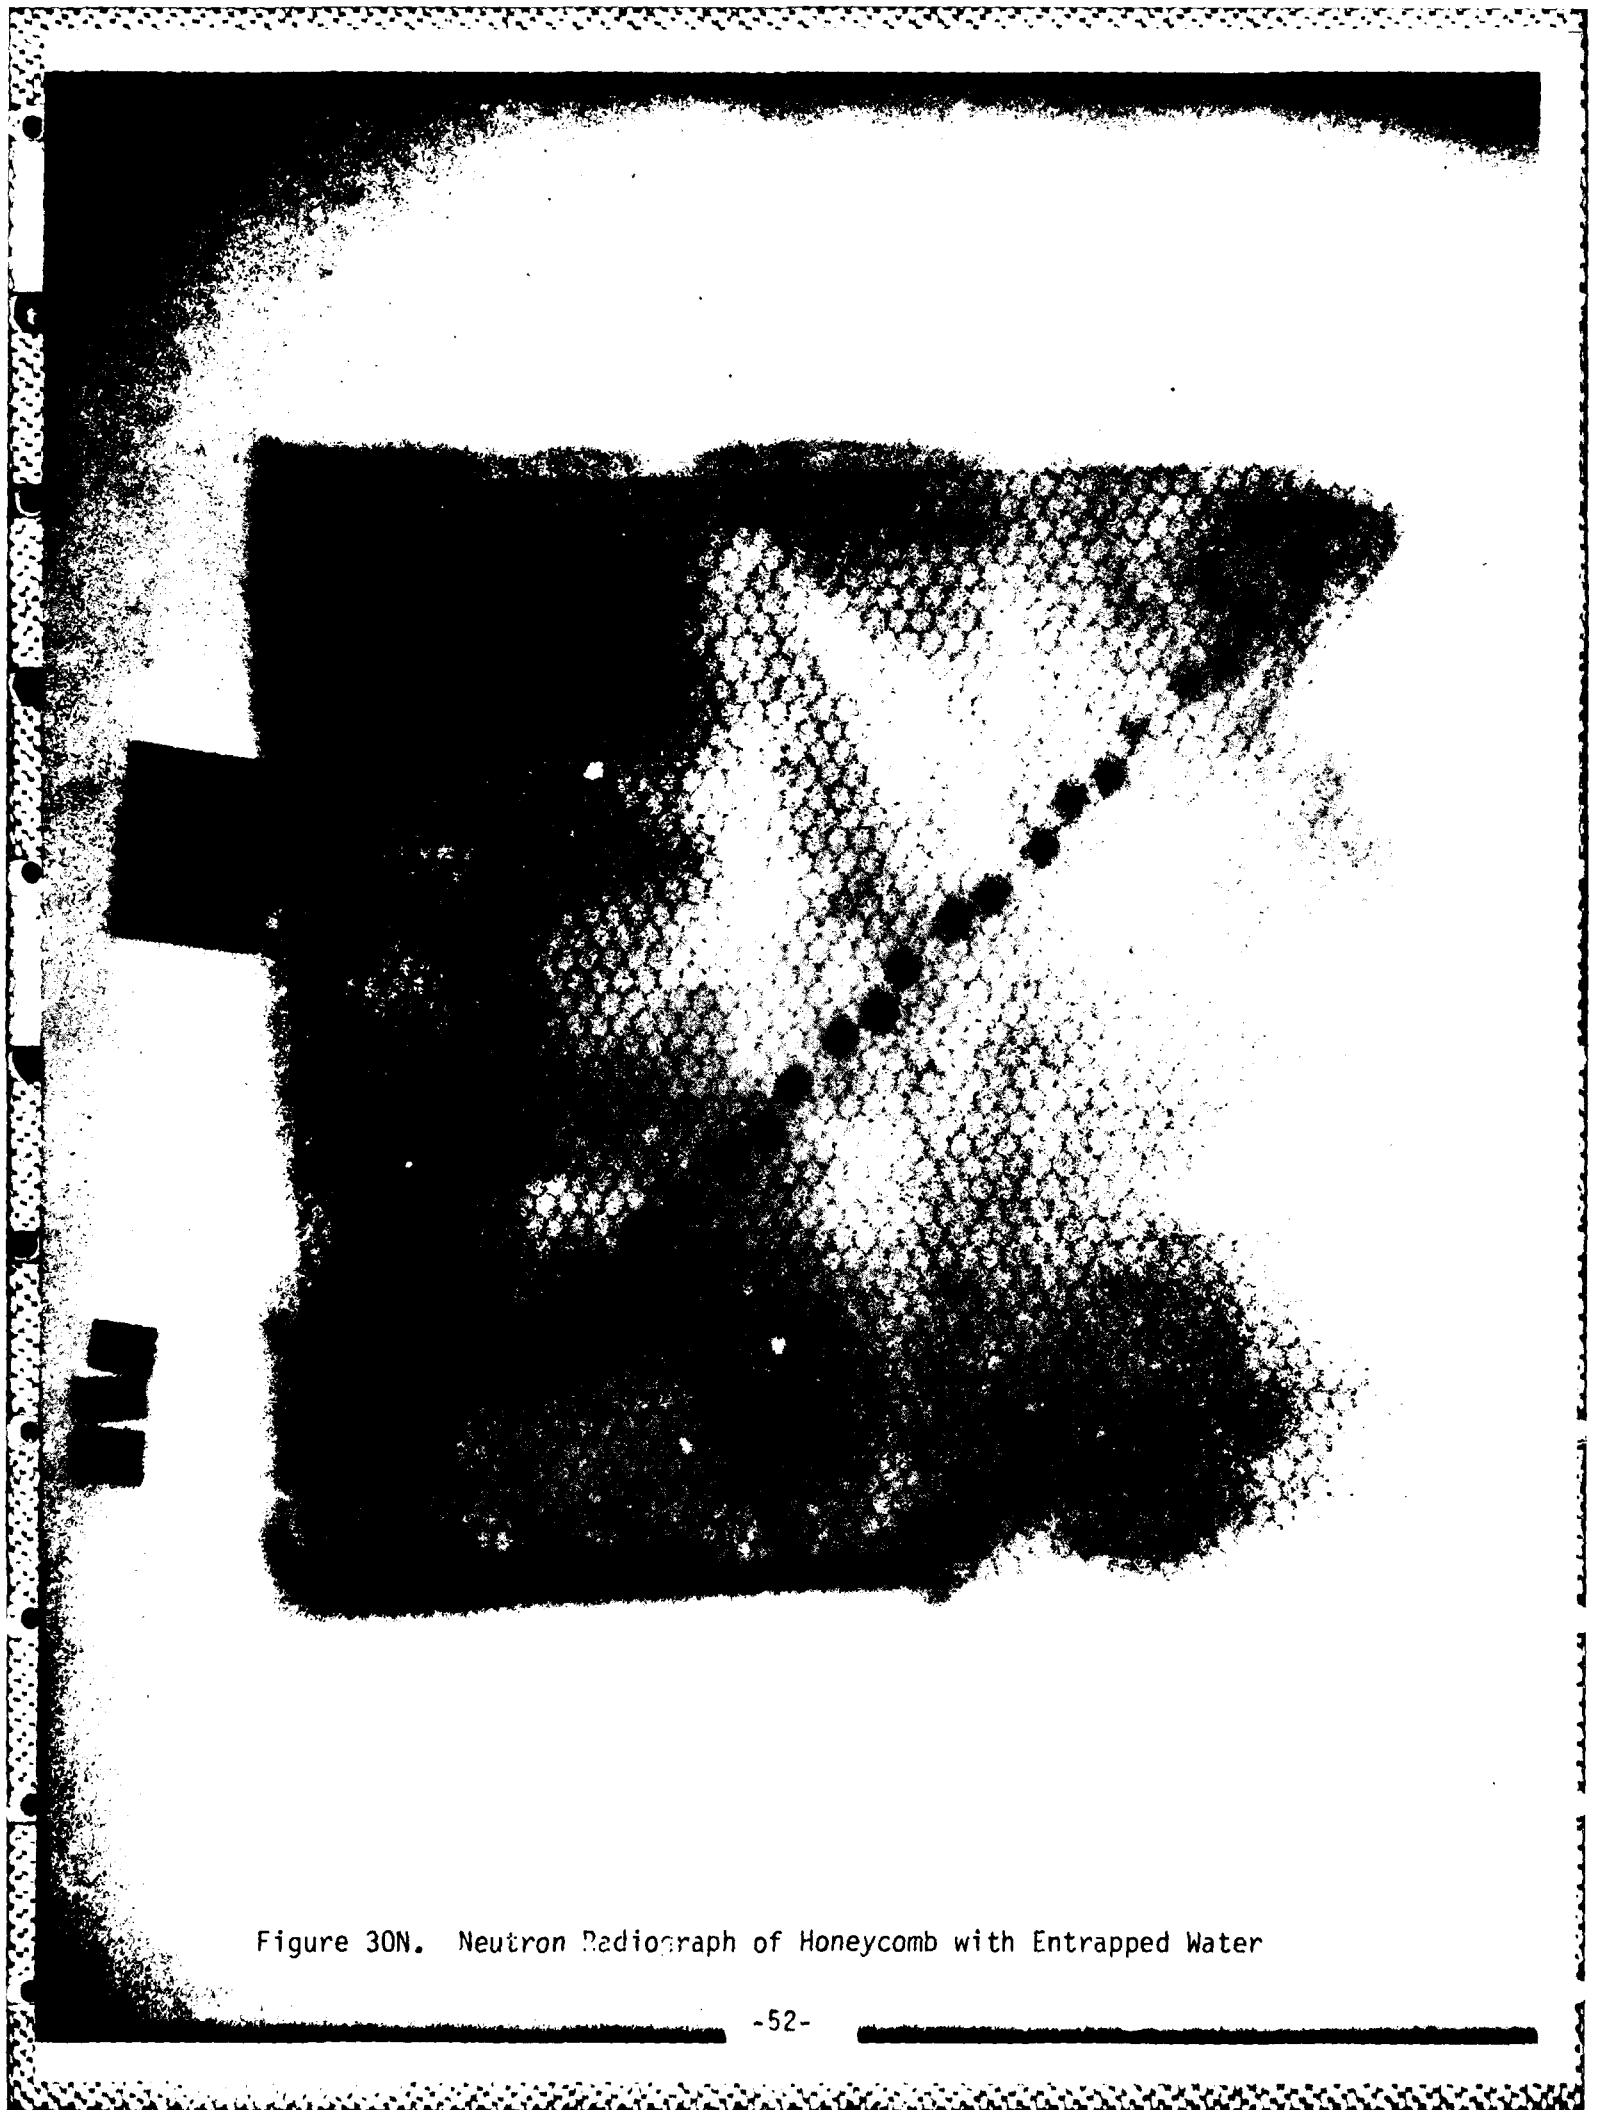
Figure 30N. Neutron Radiograph of Honeycomb with Entrapped Water

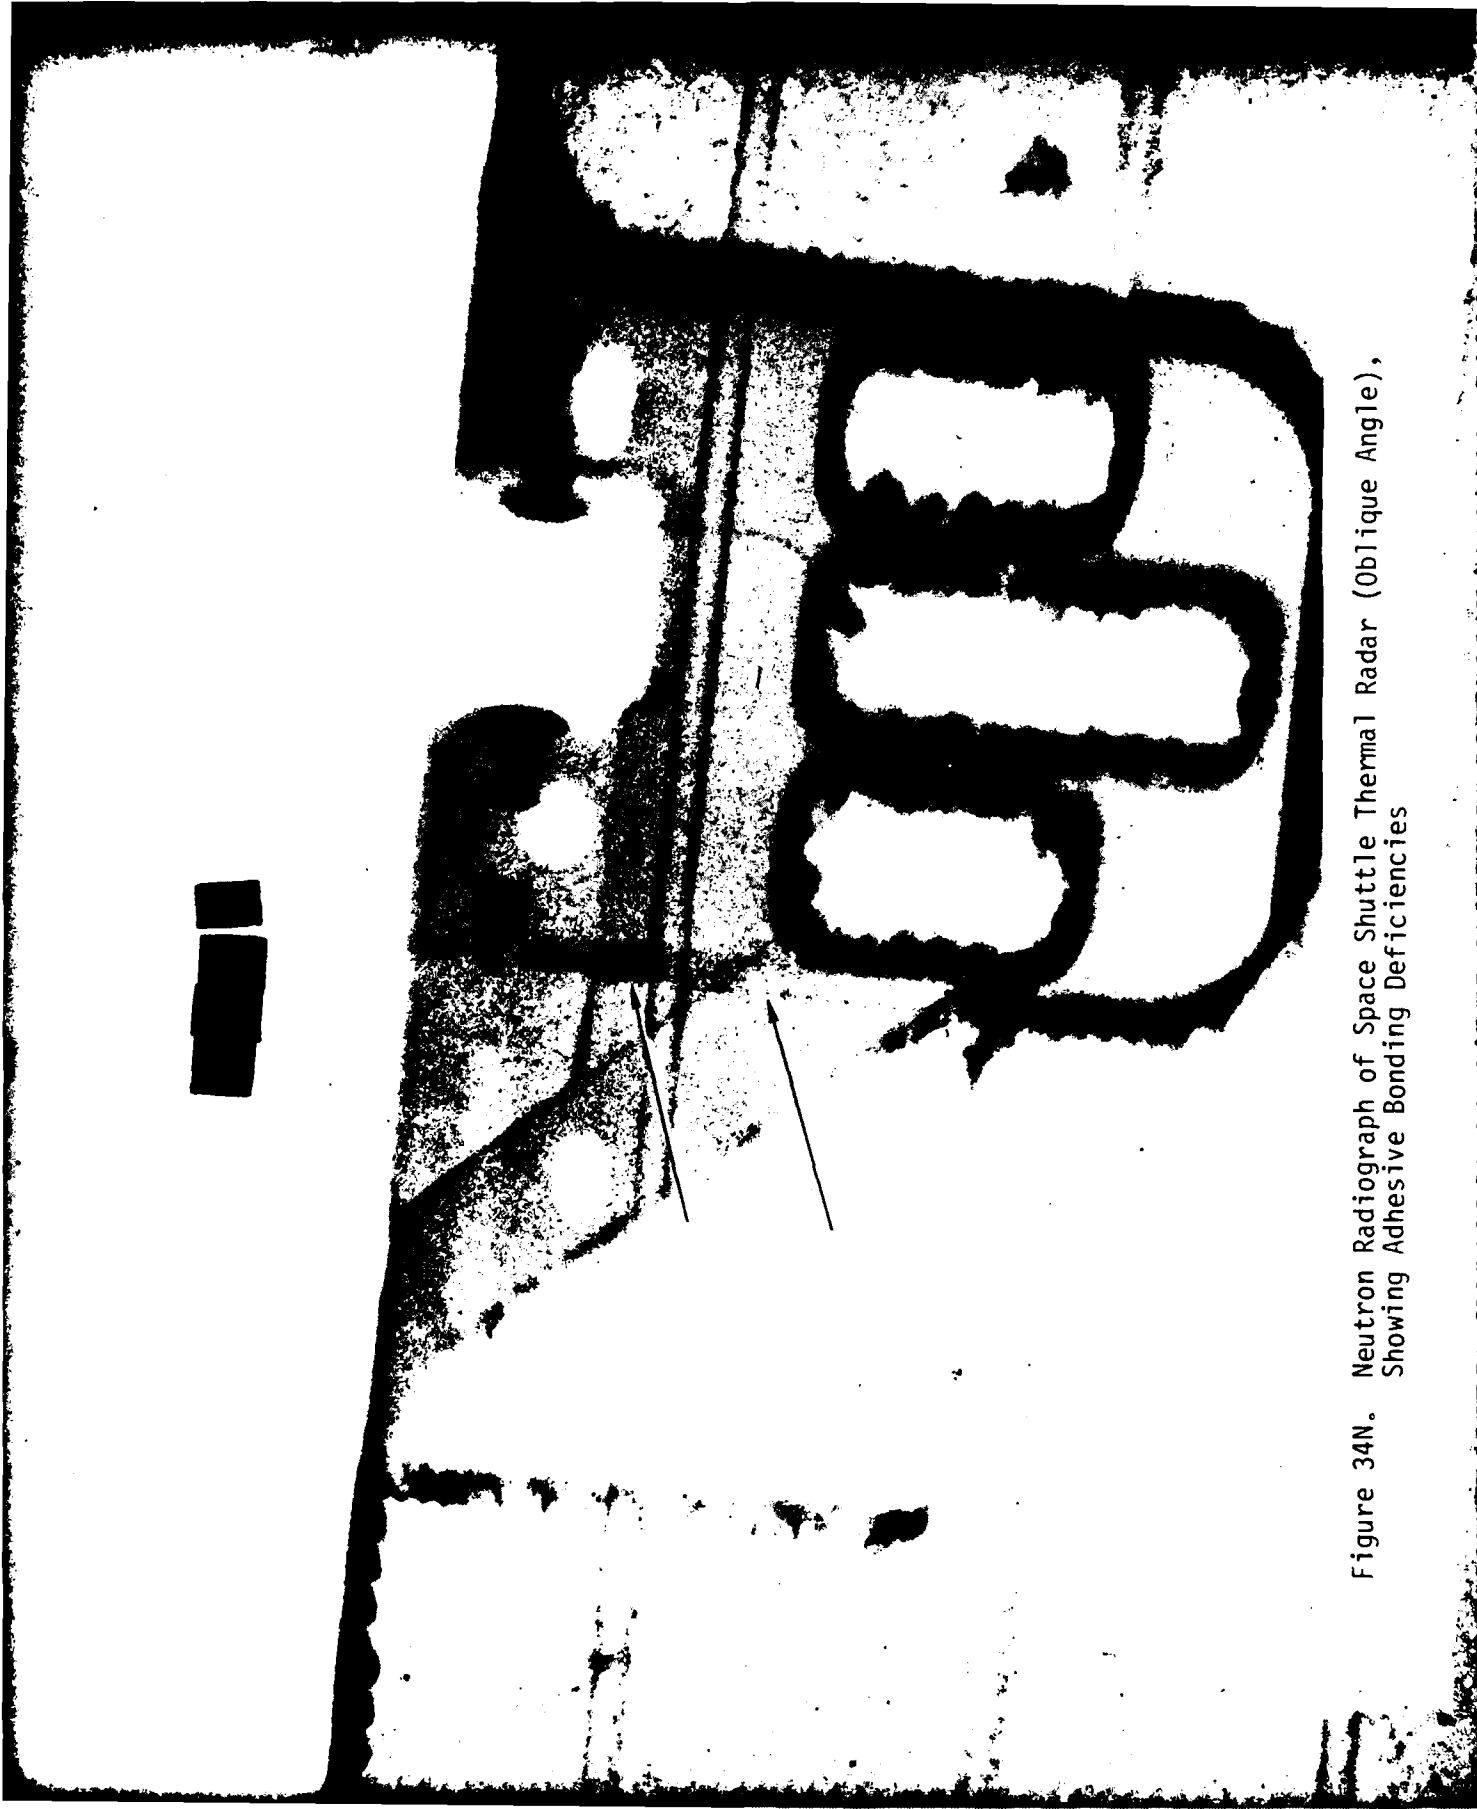
Figure 34N. Neutron Radiograph of Space Shuttle Thermal Radar (Oblique Angle),  
Showing Adhesive Bonding Deficiencies

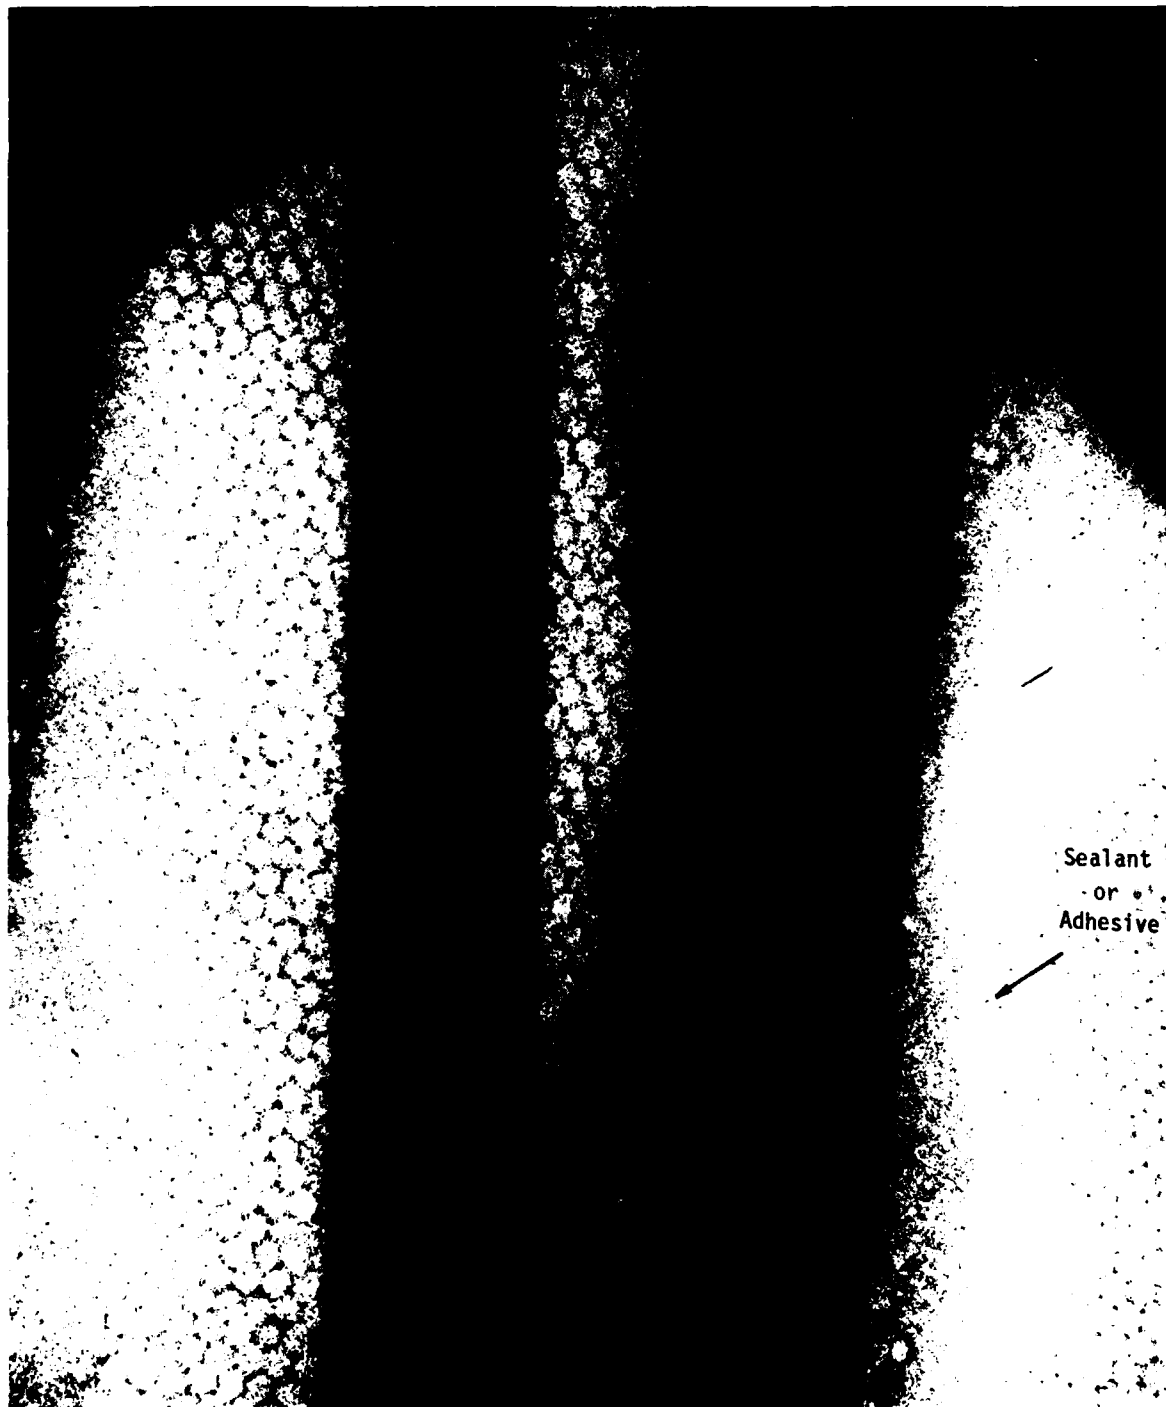
The first neutron radiograph made after arrival and setup at SM-ALC was a fast (12 minute) exposure of an F-111 right hand horizontal stabilizer attached to the aircraft. As seen in the neutron radiograph, Figure 43N, the detail is sufficient to indicate that this area was in a normal "as bonded" condition and free from significant quantities of moisture or corrosion. Subsequently, a similar component which had been removed from a different aircraft for rework because of indications of moisture and corrosion was made available by SM-ALC personnel for comparison, and the same area was neutron radiographed. This radiograph, Figure 44N, shows a very large amount of moisture and corrosion, in striking contrast to the previous radiograph of the "clean" component. The x-ray of the same area as that is shown in Figure 44X. The neutron radiograph dramatically shows more of the moisture and corrosion than does the x-ray and provides a clear indication of the boundaries and severity of these defects. Neutron inspection of a different area of the same stabilizer resulted in the radiograph shown in Figure 45N. Additional moisture and corrosion is revealed in this area of the stabilizer.

Figure 43N. Rapid In-Situ Neutron Radiograph (12 Minutes) of F-111 Horizontal Stabilizer: No Significant Moisture or Corrosion Indicated

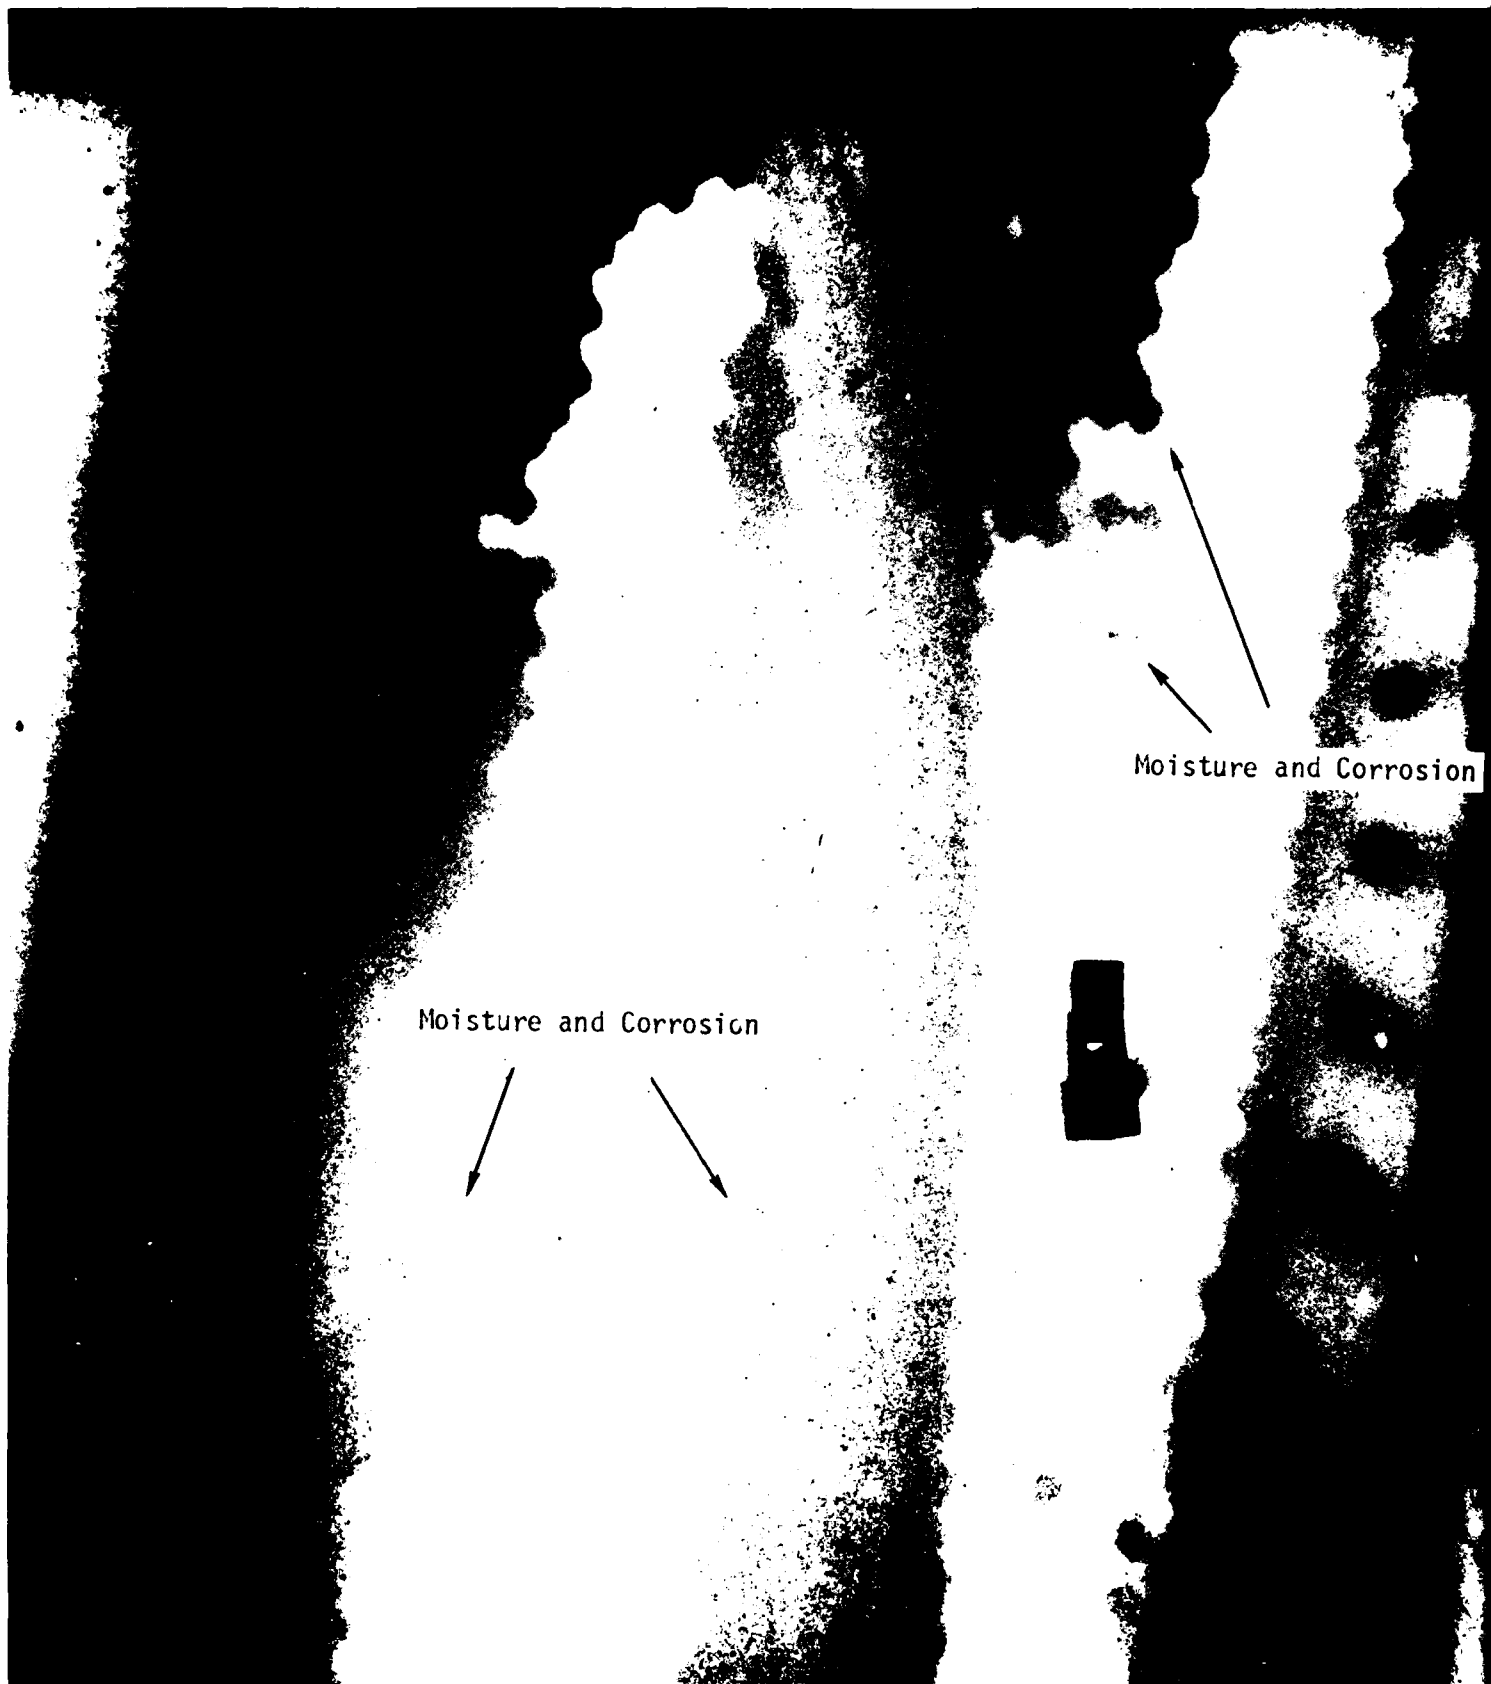
Figure 44N. Neutron Radiograph of F-111 Horizontal Stabilizer Showing Substantial Quantities of Moisture and Corrosion

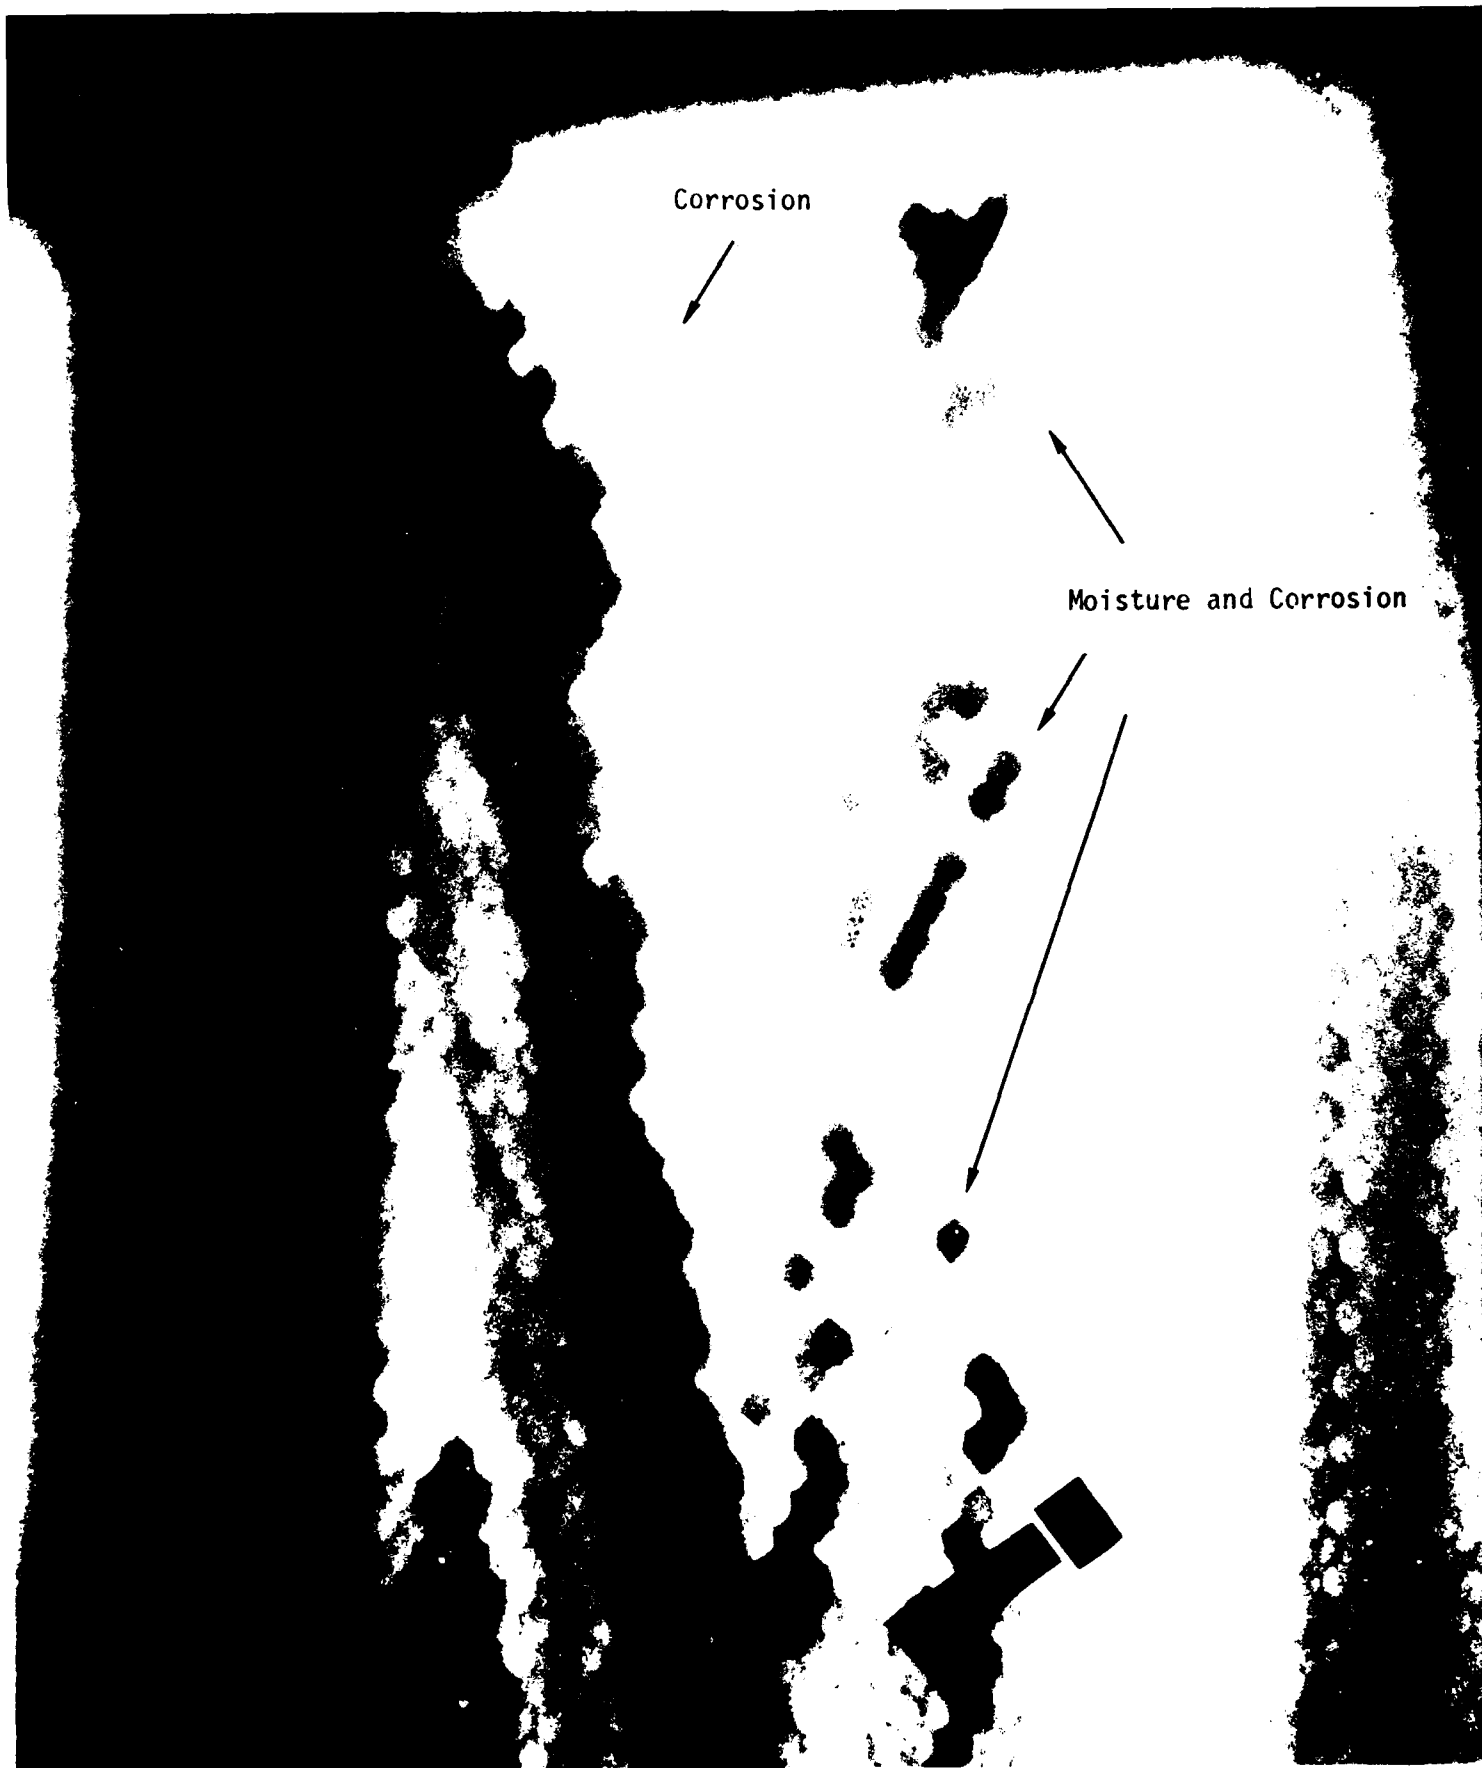
Figure 45N. Neutron Radiograph of F-111 Horizontal Stabilizer Showing Substantial Quantities of Moisture and Corrosion

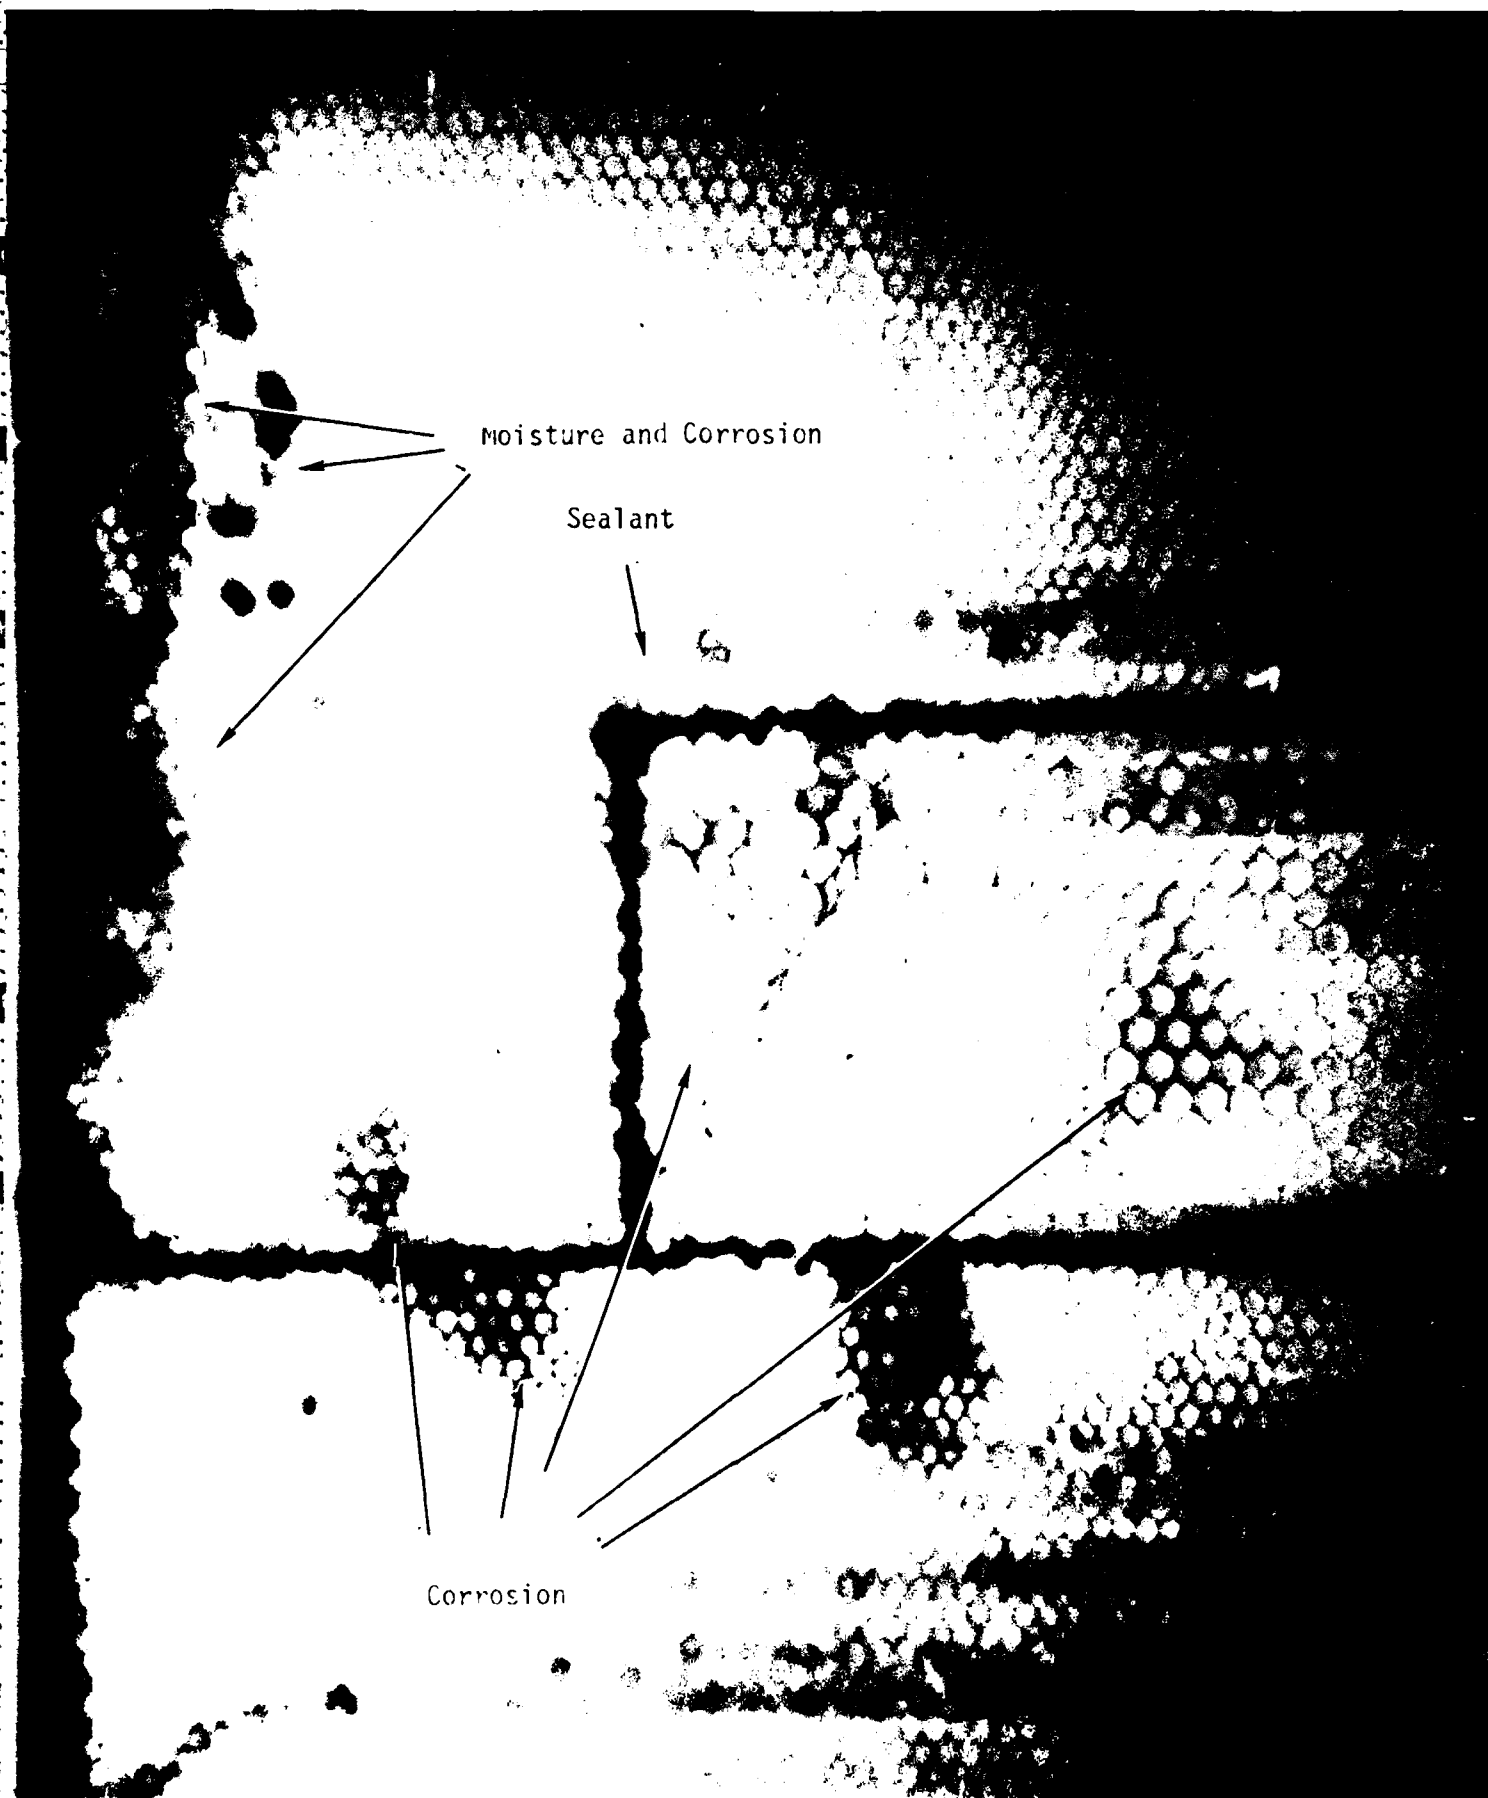
The next neutron radiograph in this series, Figure 46N, resulted from inspection of an F-111 forward engine access panel. Moisture and corrosion are clearly imaged, in addition to adhesive fillets and sealants. A very fast (3 minute) exposure of a similar panel, Figure 47N, is compared with a 90 minute exposure of the same area, Figure 48N. This comparison is made here to assess the extent to which one can trade high resolution for speed in a mobile operation and still adequately detect the defect(s) in question. As noted, the 3 minute radiograph shows sufficient detail to interpret most of the features of the 90-minute image.

Figure 46N. Neutron Radiograph of F-111 Forward Engine Access Panel Showing Corrosion, Moisture, Adhesive and Sealants

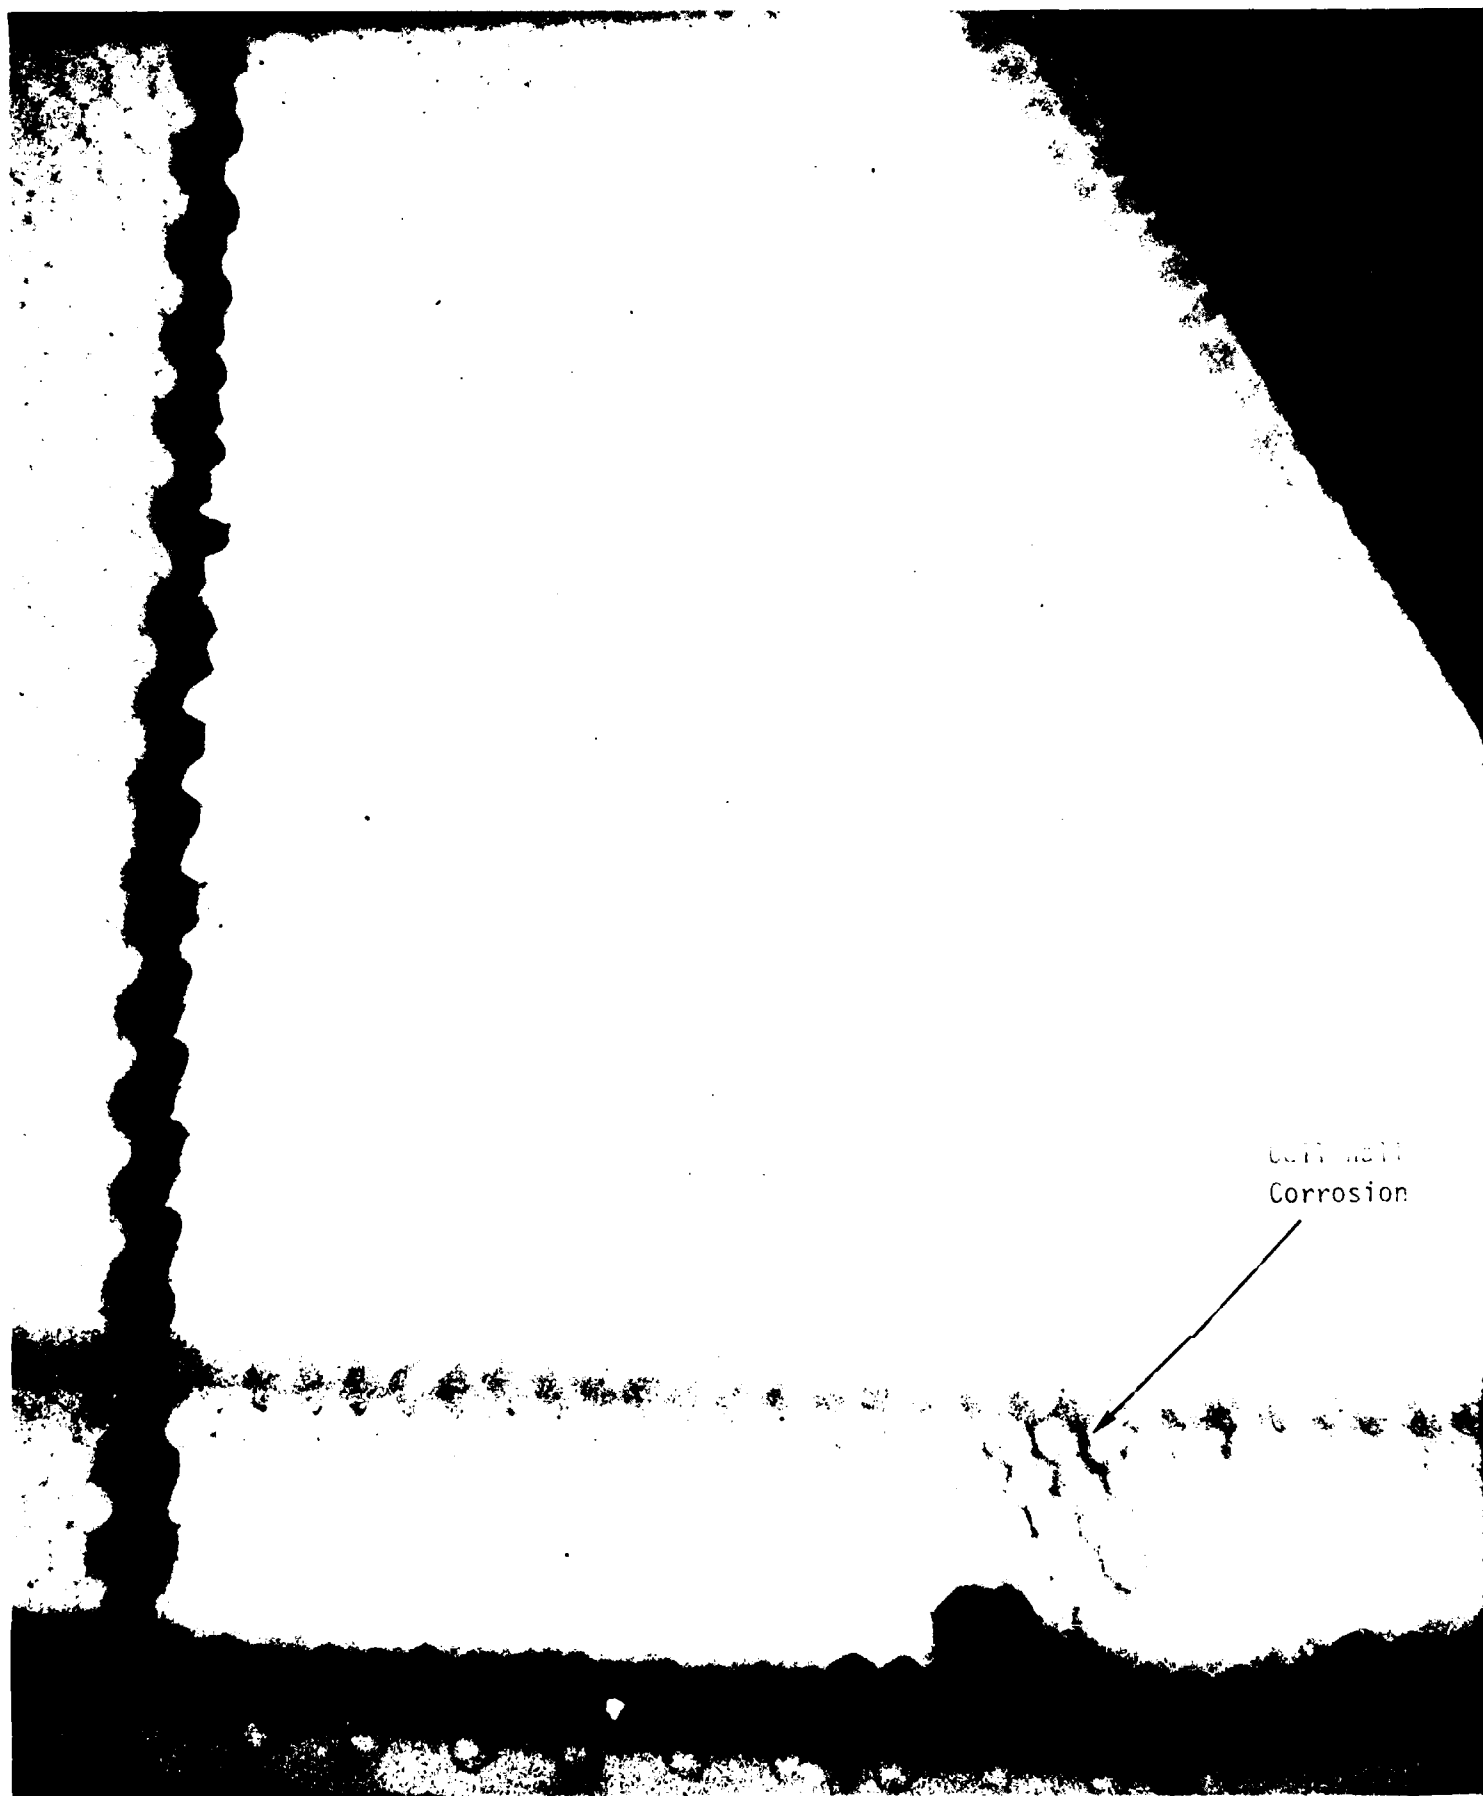
The next radiograph, Figure 49N, is the result of inspecting an F-111 horizontal stabilizer tip cap, which is shown in the photograph of Figure 50, after post-radiography removal of the skin. Prior to neutron inspection, the part was inspected by x-ray and acoustic emission, and areas of suspected moisture and corrosion as indicated by these techniques were marked on the surface of the part, as seen in the above photograph. Cell-wall corrosion is

Figure 49N. Neutron Radiograph of F-111 Horizontal Stabilizer Tip Cap Indicating Cell Wall Corrosion

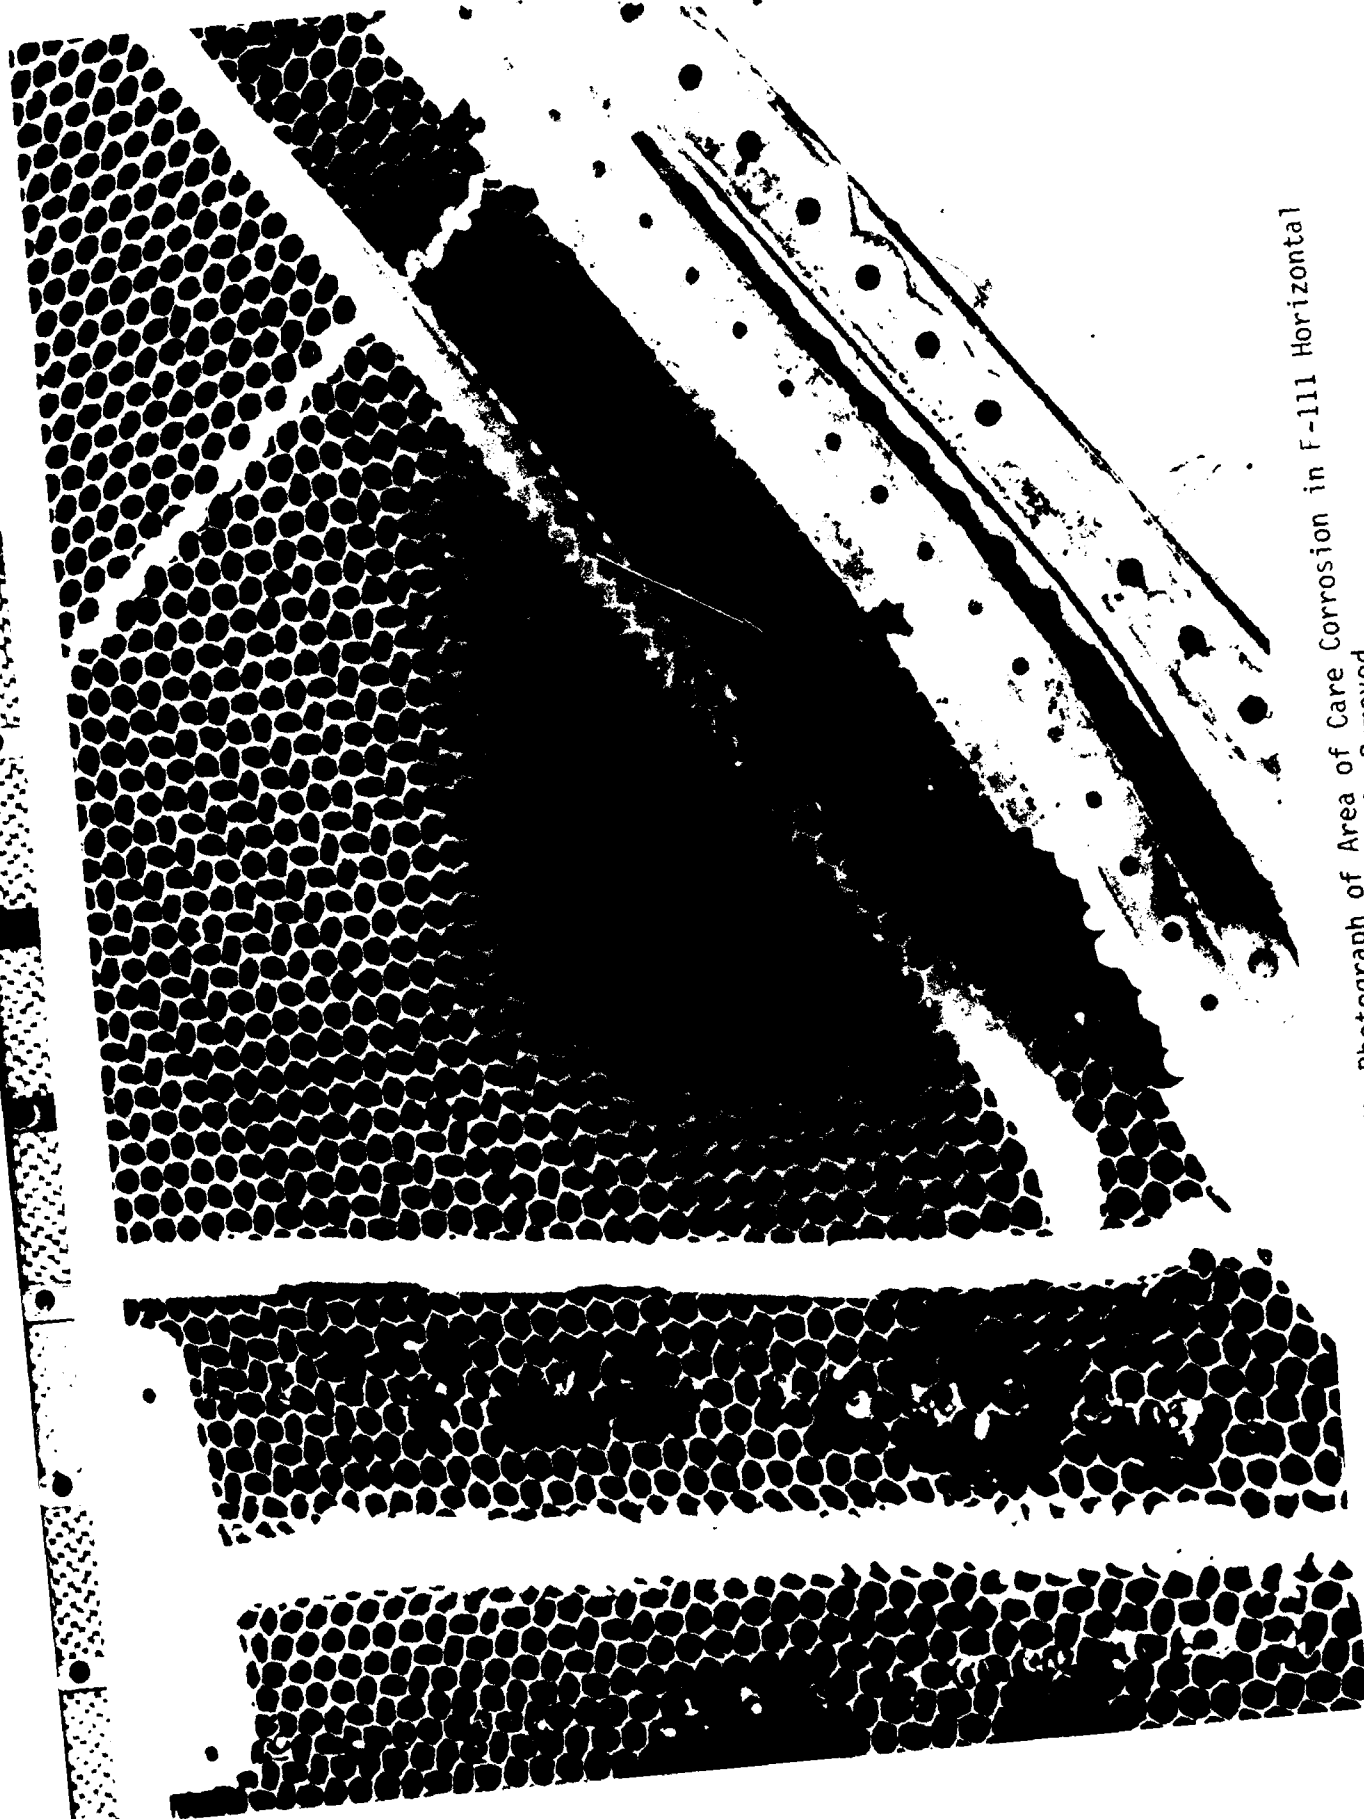
indicated in the neutron radiograph as noted by the arrow. This was verified by visual inspection after removal of the skin, as shown in the close-up photograph, Figure 51. Although acoustic emission indicated defects, x-ray inspection indicated no cell-wall corrosion.

Figure 51. Close-Up Photograph of Area of Care Corrosion in F-111 Horizontal Stabilizer Tip Cap with Skin Removed
